# Your survey and valuation report

22nd November 2021

**Surveyor's RICS number**

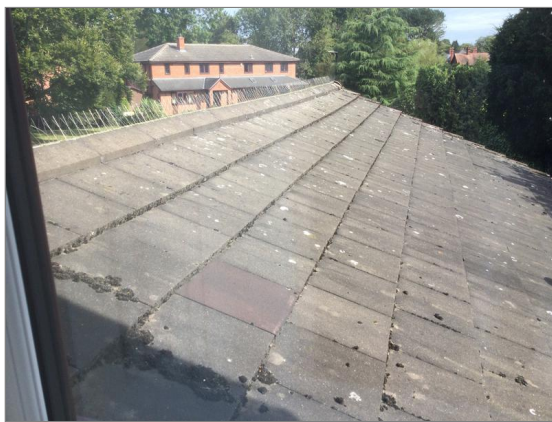
*Photo - 8*

There is moss & algae evident to the roof coverings which will increase over time and this should be removed by a qualified roofer. Condition Rating 2.

A section of the bird spike track to the main roof ridge has detached and we have considered that there is a risk that, should this slide off the roof, it could cause injury and this should be rectified (see I3). Condition Rating 3.

There are no ventilation points to the roof covering and we recommend ventilation is incorporated to the ridge tiles/roof pitches/soffits. Condition Rating 2.

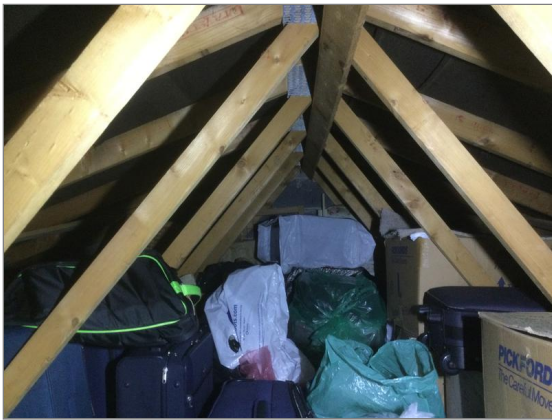
Photo - 43

There is a small tear to the roof membrane to the front roof pitch which was not a major issue and could be repaired. Condition Rating 2.

We have recommended that ventilation ridge tiles and or ventilation roof tiles (see D2) are provided to the roof covering to increase the air circulation around the roof void reducing the prospect of condensation and timber deterioration/infestation to the roof structure timbers. Condition Rating 2

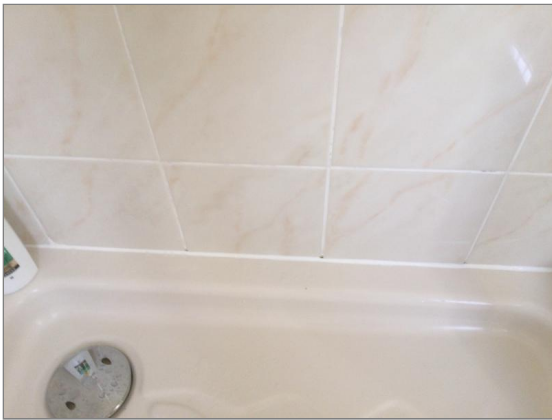
*Photo - 93*

There is some shrinkage of mastic where the wall tiling meets the ceiling which could be addressed during the preparation work prior to future decoration and, similarly, there is some further shrinkage to wall tile grout/mastic which could be addressed also during preparation work prior to future decoration with some minor shrinkage of mastic around shower tray which should also be addressed also. Condition rating 2.

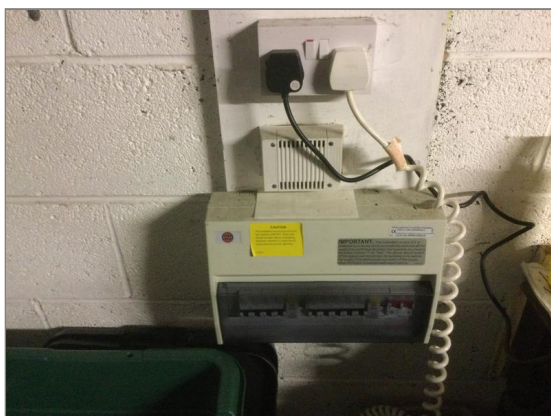
Photo - 111

There is a plastic cased consumer unit within the garage; current regulations would require a metal cased consumer unit.

We advise that a qualified electrician carries out a routine check of the electrical installation throughout, including a PAT test of any electrical appliances to be left with the property (see I1). Condition Rating 3.

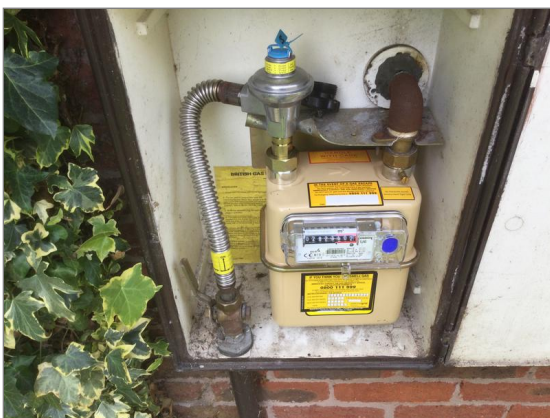
Photo - 114

Within a plastic meter box to the front elevation to the garage there is a numeric meter, gas regulator and gas lever; there was no obvious earth wire.

We advise that a qualified Gas Safe registered engineer carries out a routine check of the gas installation throughout together with any gas appliances to be left with the property (see I1). Condition rating 3.

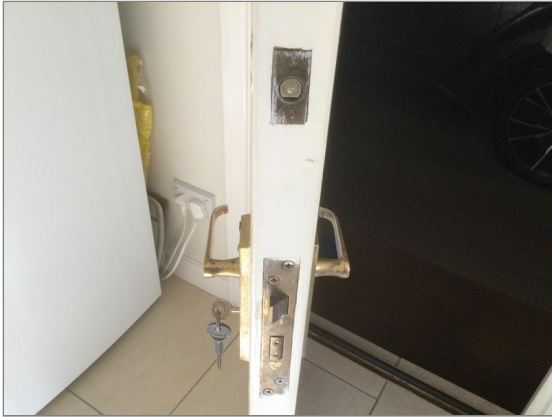
*Photo - 139*

There is a step leading up from the garage to the adjoining utility area and there is a timber framed fire door with an alarm pad. The fire door does have a self-closing device, although this does not close the door fully and if it cannot be adjusted to do so then we advise that a stronger self-closing device is fitted as this door should be closed to prevent the potential for fire and smoke spread; we would also advise that intumescent strips are fitted to the door frame/perimeter of the door which, again, would serve to reduce the potential for smoke spread (see I3). Condition Rating 3.

Care should be taken not to overload the wall shelving and one of the shelves is warped currently and realigning of the shelf brackets is advised and a replacement shelf fitted. Condition Rating 2.

There is cracking to the concrete block inner face to the left lateral wall to the garage which is the possible result of the action from the automatic main garage door over time although we have also considered that there is a copper pipe which has been fitted through this wall and adjoins the vertical cracking and we did consider also whether the installation of the pipe through the concrete block has caused this cracking; the cracking was not considered to be significant and may not progress, although should be monitored. Condition rating 2.

The floor paint to the garage floor is generally worn; there was carpeting to the garage floor also which prevented a clear view of all of the garage floor surface. Condition Rating 2.

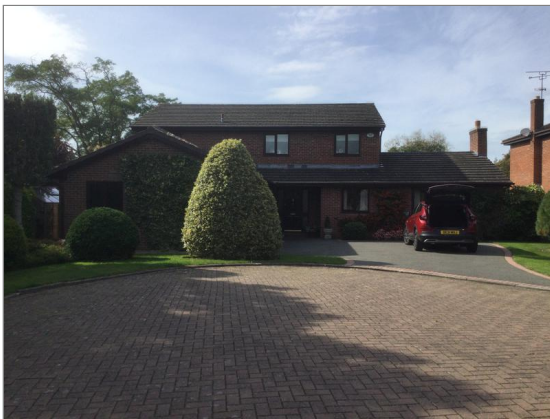
*Photo - 158*

There is cracking/unevenness within hard surfaces to the grounds, as shown in the images provided (but not limited to those shown in the images) which are a potential trip/slip hazard (see I3); these areas should be made good. Condition Rating 2.
