# Your survey report

[Address]

22nd November 2021

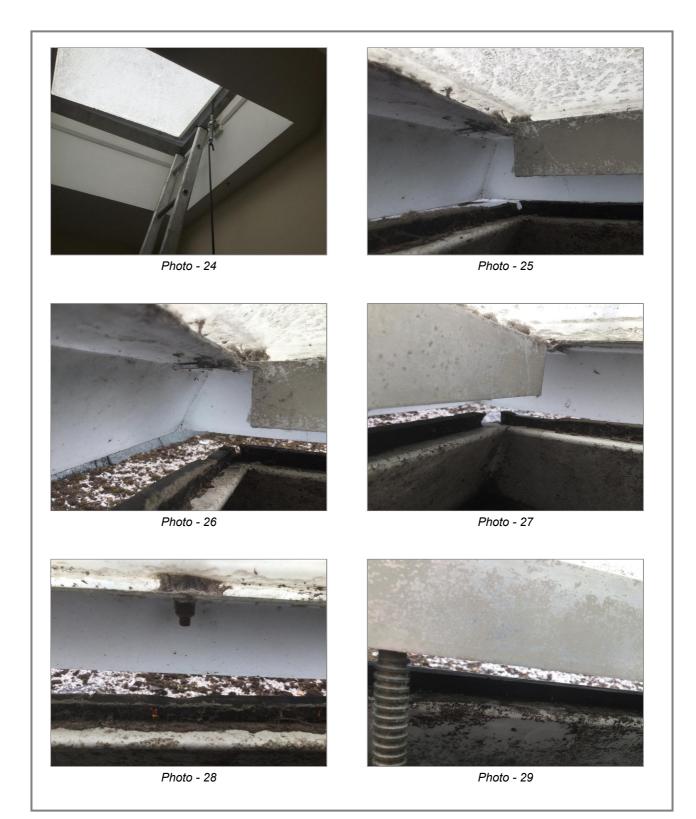
Within the top floor shower/WC there is a domed roof light heavily covered with grime and condensation can be anticipated to the inner face of the dome. There is a screw lock to this dome; the trained roofer advised under D2 should check the juncture of the dome frame with the roof covering during their inspection. Condition rating 2.
