# Your survey and valuation report

22nd November 2021

**Surveyor's RICS number**

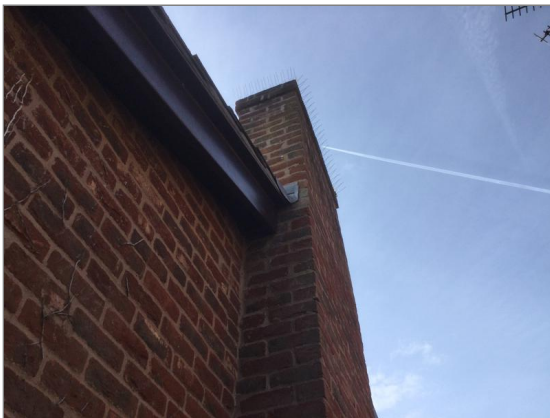
Photo - 6

To the right gable elevation to the main reception room is an exterior chimney breast with a ventilated clay chimney pot and this stack is lead flashed and aproned to the roof covering; there are bird spikes around the top of the chimney stack and also the chimney pot. Condition Rating 1.

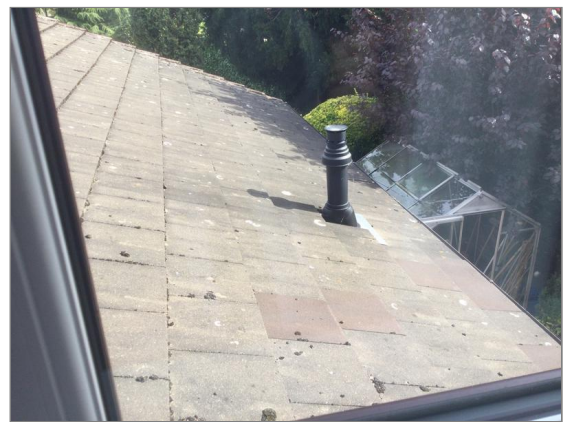
*Photo - 9*

There is moss & algae evident to the roof coverings which will increase over time and this should be removed by a qualified roofer. Condition Rating 2.

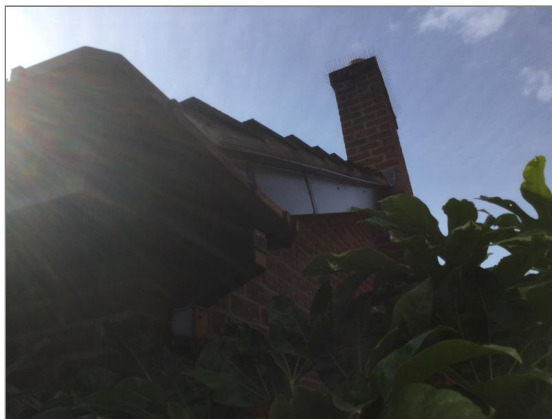
*Photo - 10*

A section of the bird spike track to the main roof ridge has detached and we have considered that there is a risk that, should this slide off the roof, it could cause injury and this should be rectified (see I3). Condition Rating 3.

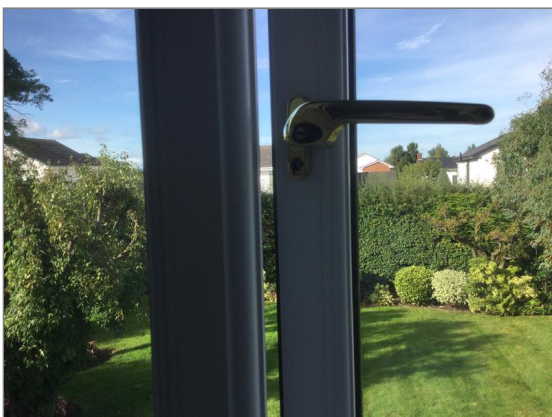
*Photo - 21*

There are PVC double glazed windows. Condition rating 1.

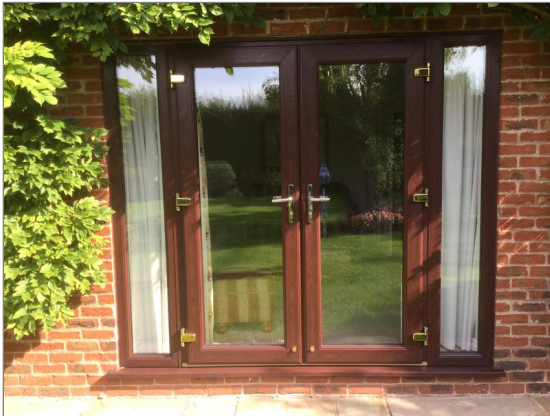
Photo - 23

To the utility area there is a PVC framed and moulded PVC door with part double glazing and a PVC sill; to the rear of the kitchen there are a pair of PVC framed and PVC double glazed doors with a PVC sill and to the dining room there are a pair of PVC framed and double glazed doors with fixed double glazed side panels; there is a part glazed front door with double glazed side panels adjoining. Condition rating 1.

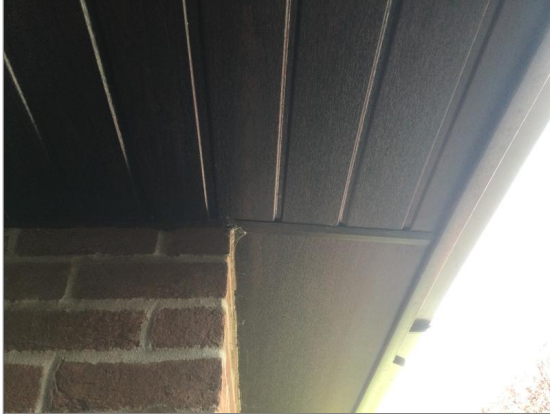
*Photo - 42*

See our comments under D7; outside decorations help keep the property in satisfactory condition. Without a protective finish, parts will quickly deteriorate requiring extensive repairs. To prevent this, the external surfaces should be redecorated on a routine basis (see D7). Condition rating 2.

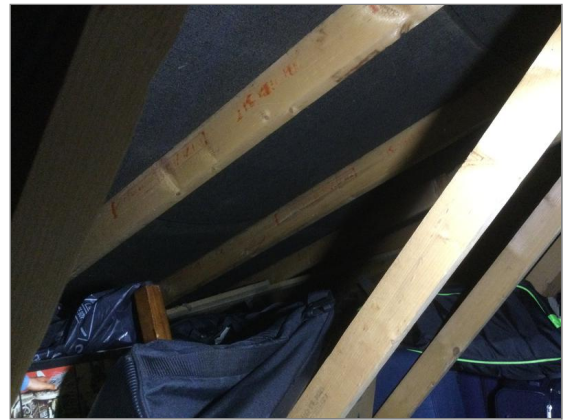
Photo - 44

There is a small tear to the roof membrane to the front roof pitch which was not a major issue and could be repaired. Condition Rating 2.

We have recommended that ventilation ridge tiles and or ventilation roof tiles (see D2) are provided to the roof covering to increase the air circulation around the roof void reducing the prospect of condensation and timber deterioration/infestation to the roof structure timbers. Condition Rating 2

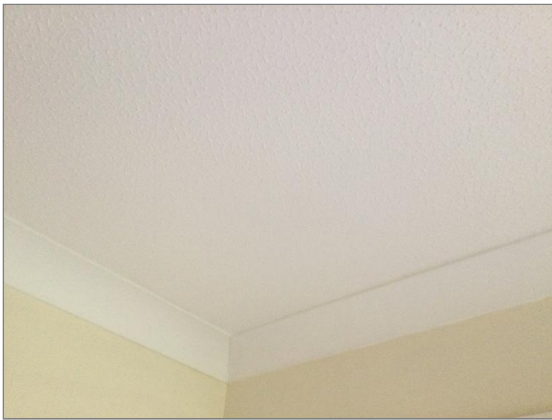
*Photo - 53*

There are plasterboard ceilings with a plaster skim finish, and there are plasterboard cornices, there are ceilings with textured finishes (see I3) and we have consider that textured finishes could contain asbestos fibres. Condition rating 2.

It is not unusual to find cracking to plasterboard joints, the usual result of thermal shrinkage and this type of cracking can be addressed during the preparation work prior to future decoration.

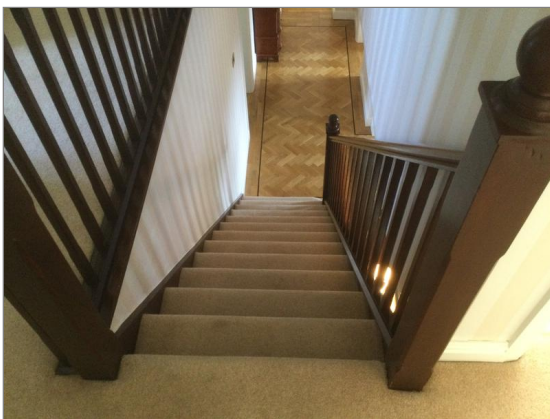
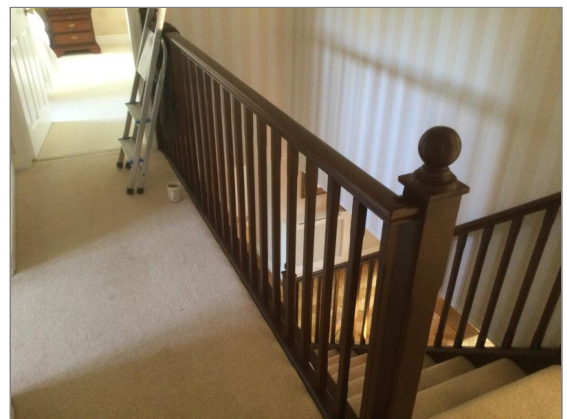
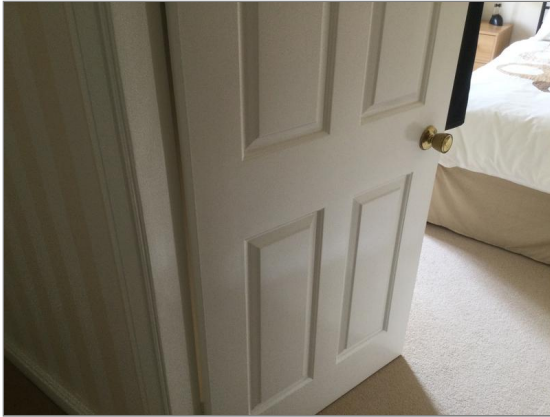
There are painted skirting boards, architraves, reveals and windowsills; there is a single flight staircase with an understairs cupboard and there are timber banisters, spindles and newel posts. Condition Rating 1.

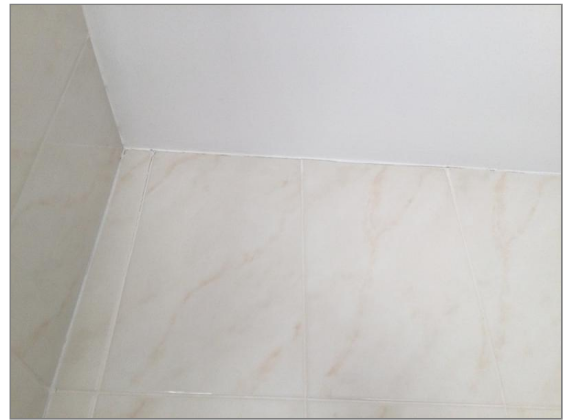
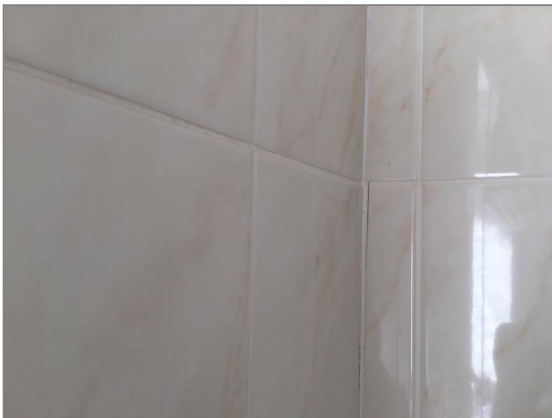
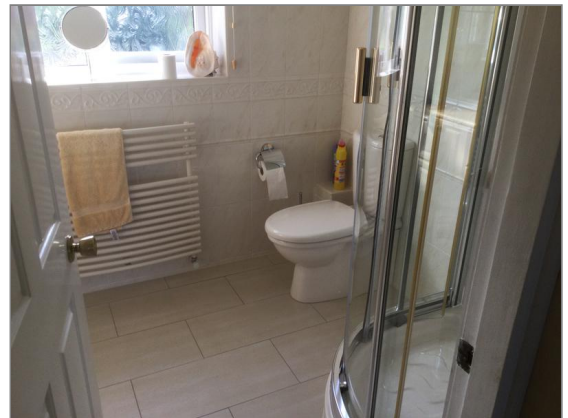
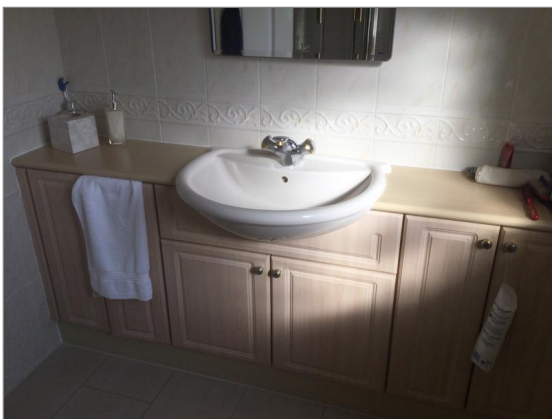
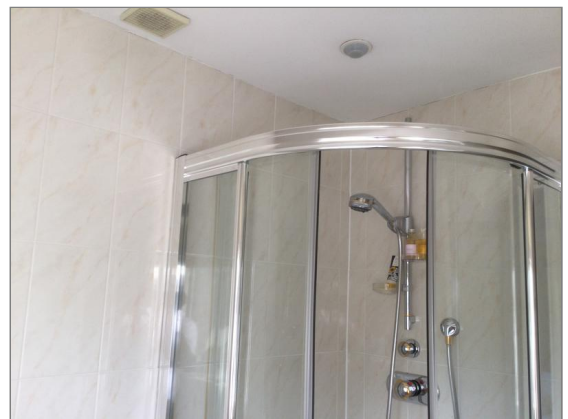
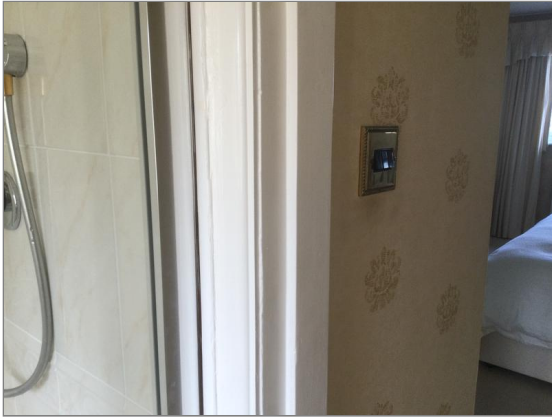
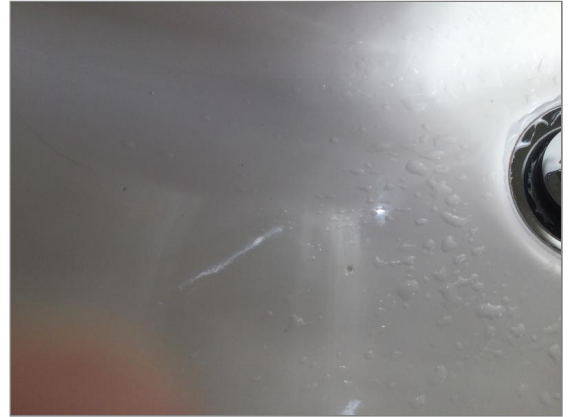
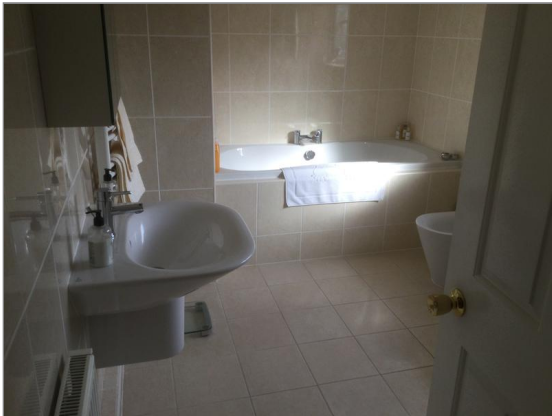
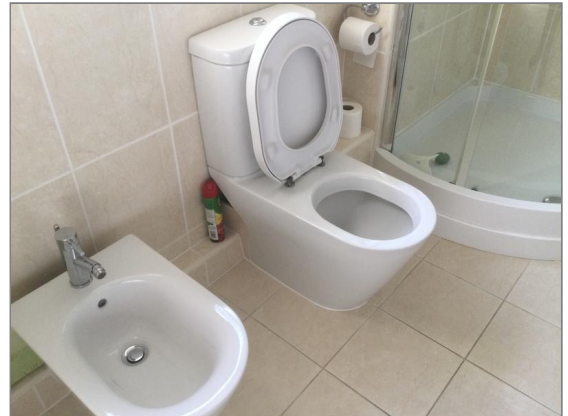
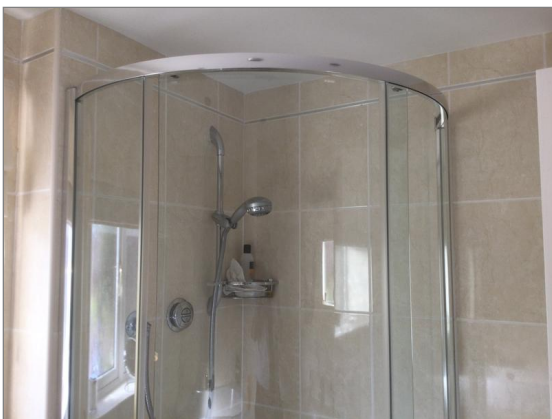
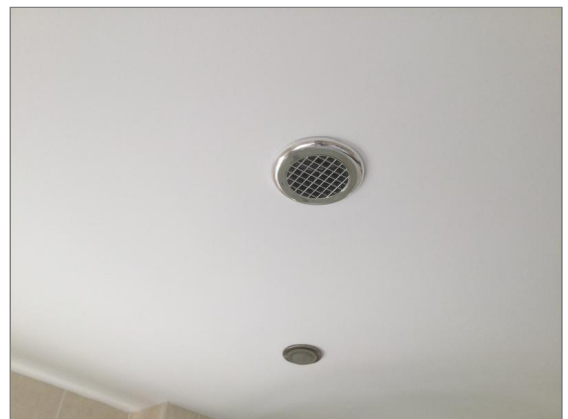
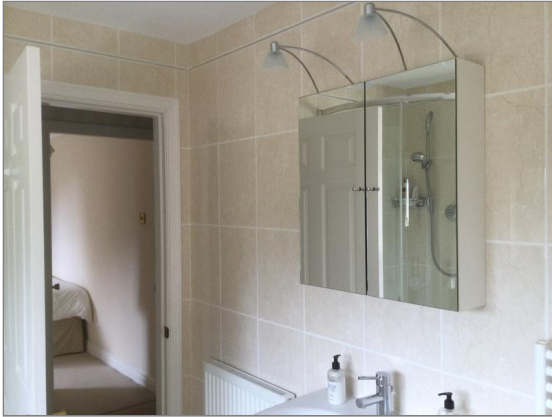
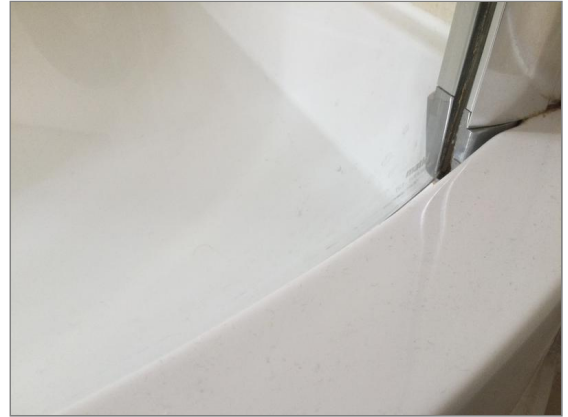
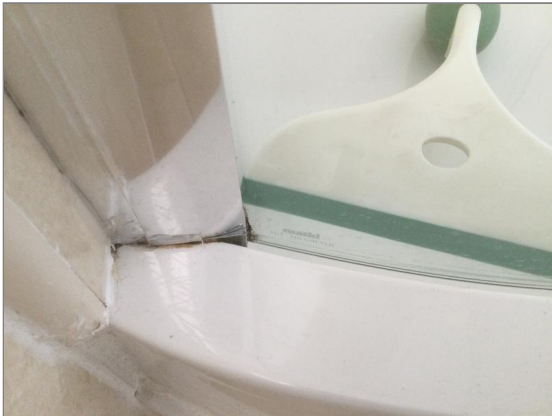
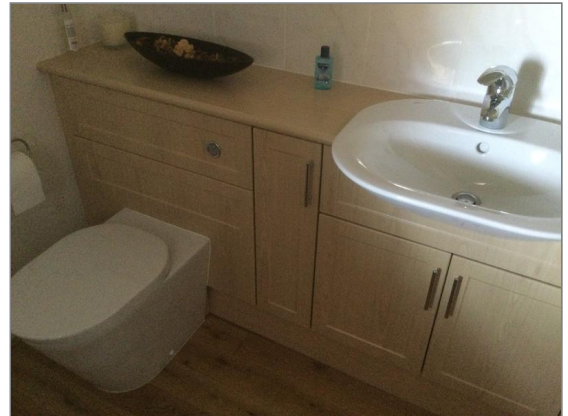
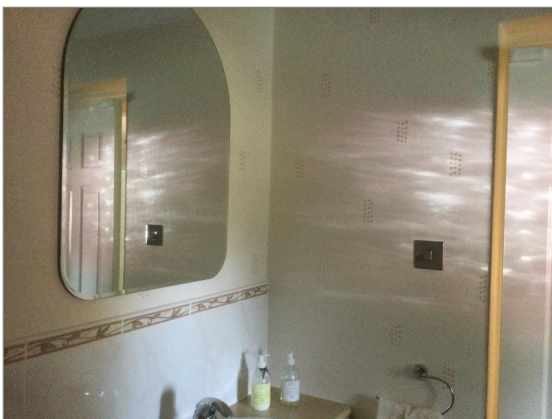
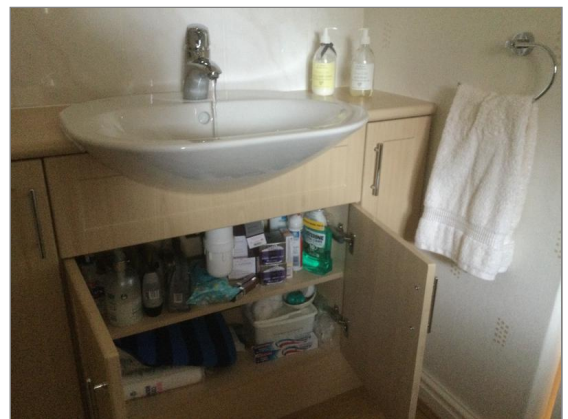
There is some shrinkage of mastic where the wall tiling meets the ceiling which could be addressed during the preparation work prior to future decoration and, similarly, there is some further shrinkage to wall tile grout/mastic which could be addressed also during preparation work prior to future decoration with some minor shrinkage of mastic around shower tray which should also be addressed also. Condition rating 2.

Occasional replacement of the mastic to the shower tray, panel bath and pedestal wash basin will be required and it should be considered that during replacement that the underlying silicon, where these fittings adjoin the walls, should not be damaged as this would enable water to pass through to the underlying floor/ceiling locations.

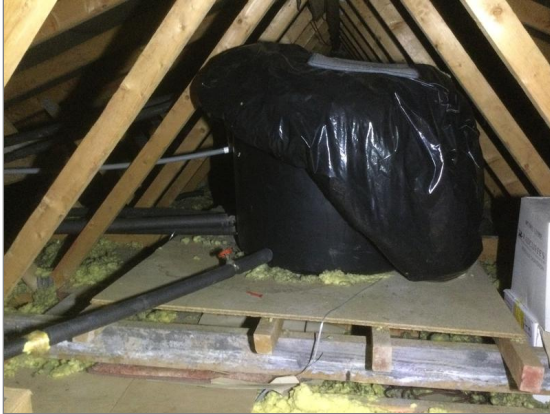
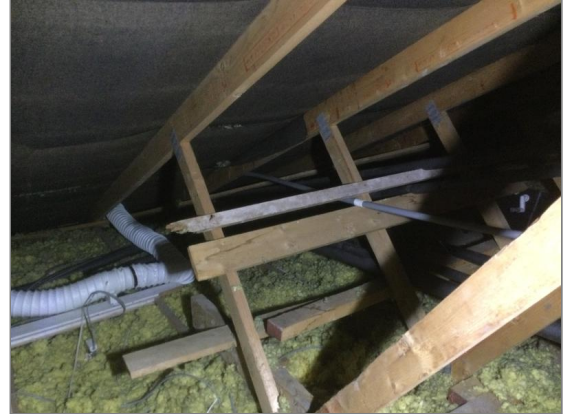
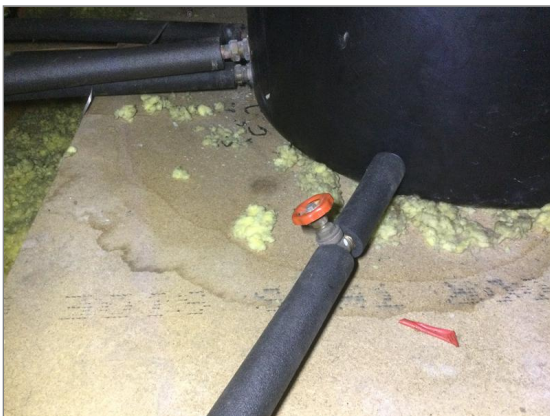
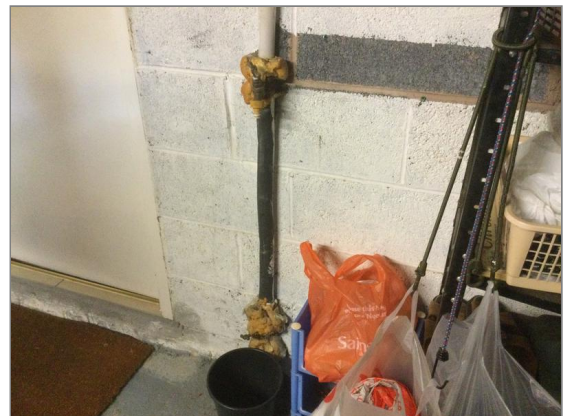
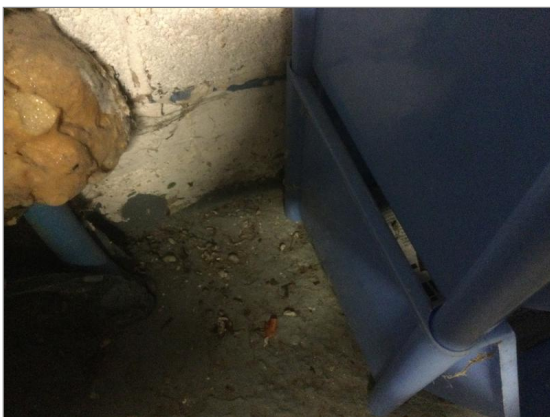
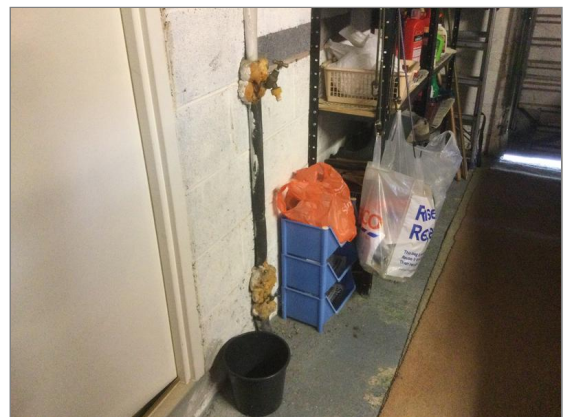
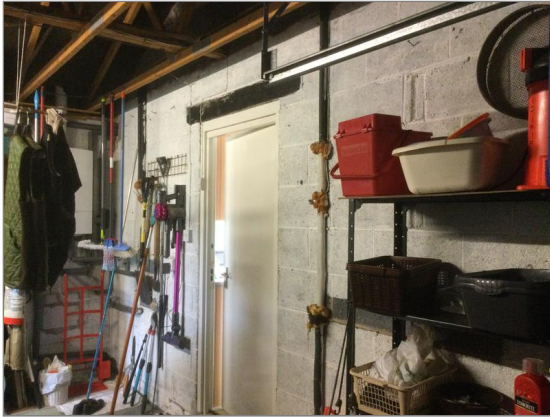
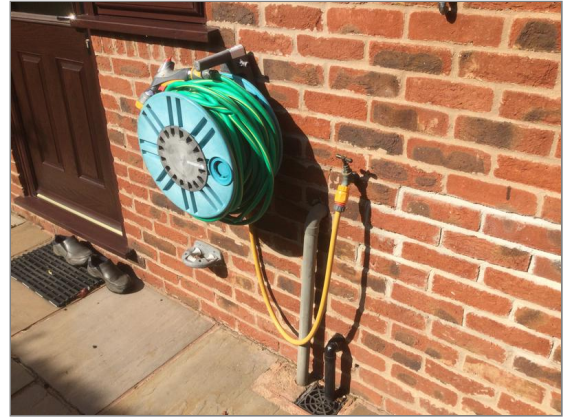
water tank with stop cock adjoining and a plastic outflow pipe with jacket insulation (our view was restricted and we could not tell with there was a smaller tank adjoining). There is water staining to the boarding supporting the water tank although no obvious evidence of any ongoing leakage. Refitting of the jacket insulation to the water tank is required to ensure that it is fully covered. Condition rating 2.

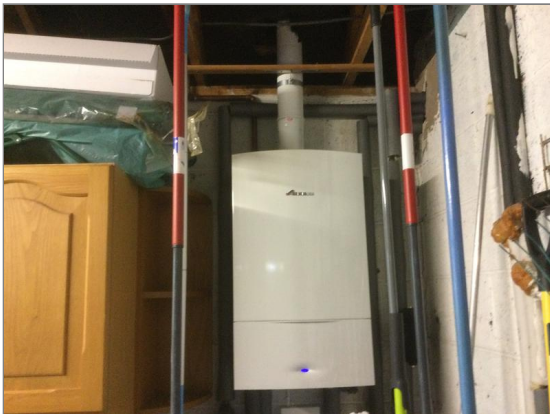
Photo - 124

Within the garage there is a Worcester gas fired boiler. There are radiators with thermostatic radiator valves within the accommodation and the two radiators to the entrance hall have ornate boxed casing. See our comments under F2, F5 & under H2.

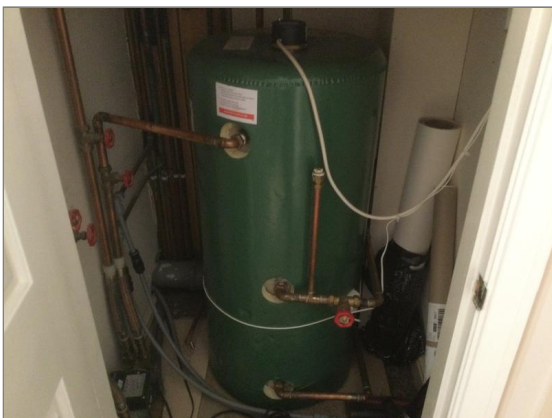
*Photo - 129*

Within the landing airing cupboard there is a foam insulated hot water cylinder with electric immersion heater and thermostat with stopcock; there are also Aqualisa digital pump units and there is a Monsoon pump within this cupboard also.

The provision of hot water via an electric immersion heater is comparatively expensive and the heating engineer advised under F2, F4 should advise you further. In the event of the Worcester boiler being a combination condensing boiler then, other than perhaps back up, there would be no requirement for the water tank in the roof void nor the hot water cylinder installation.

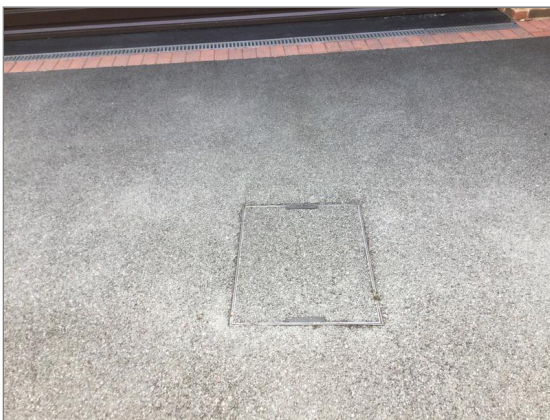
Photo - 132

Mains drainage is connected to the property and there are inspection chambers and rodding points within the grounds; the inspection chamber lids were not lifted and considering the type of lids, this should be carried out by a trained drainage engineer/trained plumber.

As a precautionary measure and considering the trees and shrubbery within the grounds of the subject property and adjoining the party boundaries within the neighbours grounds, invasion and movement of the drains by roots has been considered and we recommend, as a precautionary measure that a qualified drainage engineer or qualified plumber carries out a camera inspection of the drains serving this property (see I3 & J1). Condition Rating 3.

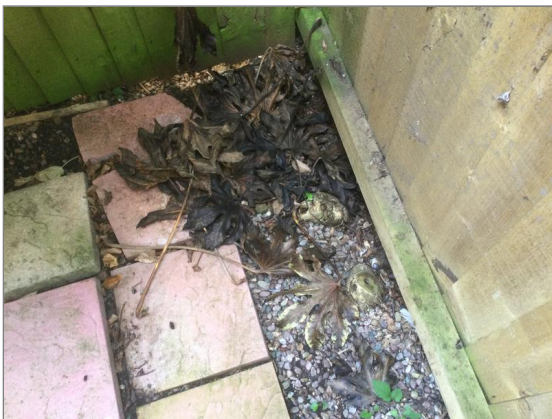
*Photo - 153*

There are mature trees/mature shrubbery adjoining the grounds which should be maintained and there are overhanging branches to the boundaries; we have considered the prospect of root invasion into the drainage

Although greenhouses lie outside the scope of this report it should be considered that most greenhouses and other glazed garden buildings are built without safety glass and can be a danger to people who fall against them (see section I3).

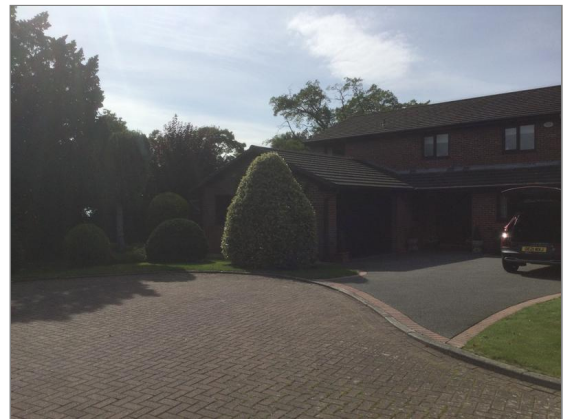
*Photo - 159*

There is cracking/unevenness within hard surfaces to the grounds, as shown in the images provided (but not limited to those shown in the images) which are a potential trip/slip hazard (see I3); these areas should be made good. Condition Rating 2.
