LEVEL 1

Your survey report

About the inspection and report

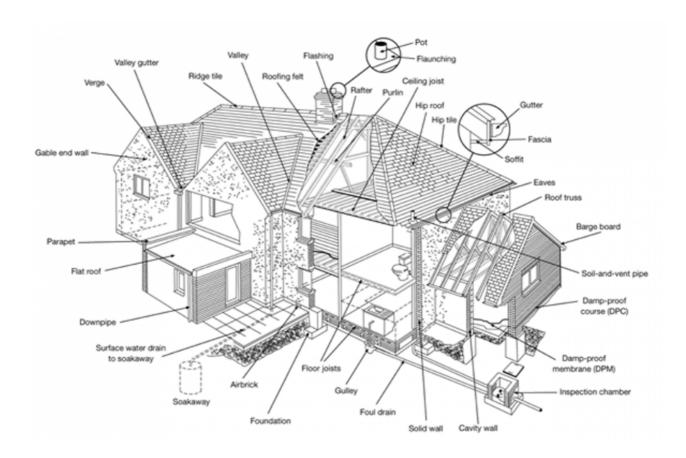
Typical house diagram

This diagram illustrates where you may find some of the building elements referred to in the report.
